DESIGN AND PRODUCTION OF DAMAGE-RESISTANT TRAY PACK CONTAINERS

RICHARD D. CUMMINGS
JULY 1985
FINAL REPORT 1984-1985

CUMMINGS SOLAR CORPORATION
WILMINGTON, MASSACHUSETTS

UNITED STATES ARMY NATICK
RESEARCH, DEVELOPMENT AND ENGINEERING CENTER
NATICK, MASSACHUSETTS 01900
FOOD ENGINEERING DIRECTORATE

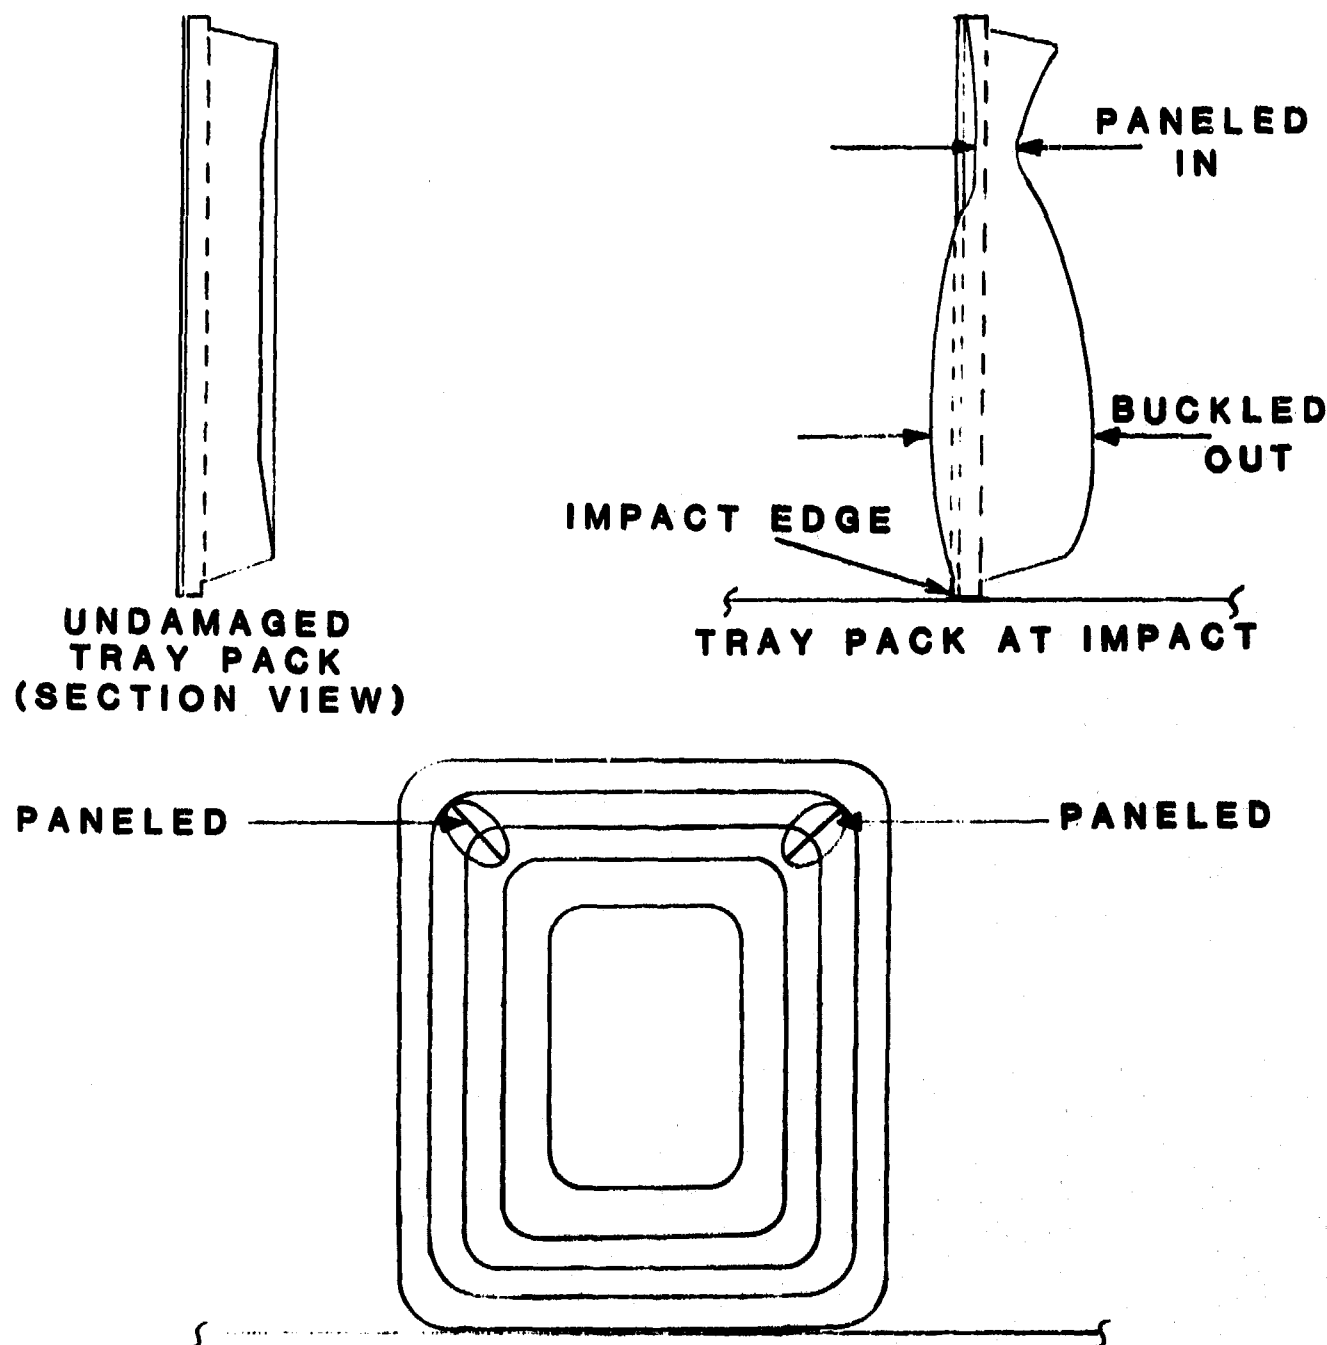
FIGURE 4.
TRAY PACK BUCKLING AND PANELING DAMAGE

As stated previously the causes of this damage are a combination of the vacuum in the container and the hydrodynamic forces in the fluid (food) packed in the container. Cummings Solar Corporation results show that the greater the vacuum, the larger the paneling (inward buckling) of the tray body. Similarly, if an overpressure is applied to the container, Cummings Solar Corporation found that the greater the overpressure, the larger the buckling (outward bulging) of the lid.

Buckling (bulging) of the Tray Pack sides is also caused by excessive vacuum. As stated previously, vacuum packing of Tray Packs results in atmospheric forces crushing the tray body

and lid together until these crushing forces are resisted by the fluid (food) in the Tray Pack. When a Tray Pack which is underfilled and vacuum-packed is dropped on its bottom, the fluid in the Tray Pack creates an overpressure on the sides causing them to buckle (bulge) outward.

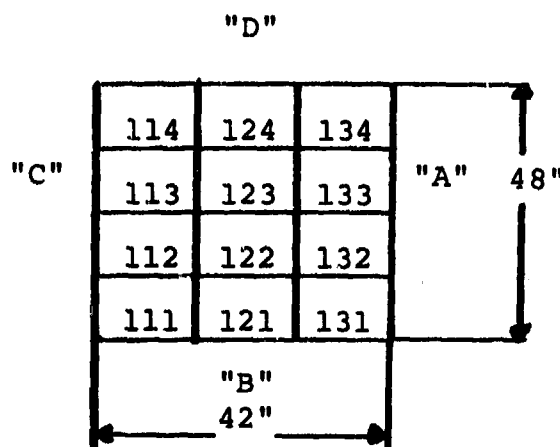
EDGE IDENTIFICATION:

EDGE	OBSERVATIONS
6" DROP EDGE "B"	LOAD SHIFTED SLIGHTLY TOWARD DROP EDGE. CENTER TIER WITH NO STRAP SHIFTED $\frac{1}{2}$ " MORE THAN REST OF LOAD.
6" DROP EDGE "D"	TIERS 2, 3 & 4 RETURNED TO CENTER. TOP TIER SHIFTED SLIGHTLY TOWARD DROP EDGE.
6" DROP EDGE "C"	LOAD SHIFTED SLIGHTLY TOWARD DROP EDGE. SOME CARTON SEPARATION IN ROWS 1 & 2.
6" DROP EDGE "A"	LOAD RETURNED TO CENTER. SOME SLIGHT MISALIGNMENT OF CARTONS IN 1ST TIER.
